## Accident rates fall

## Tanker explosions!

# CEMEX Safety Alert

## Serious injury whilst preparing for maintenance

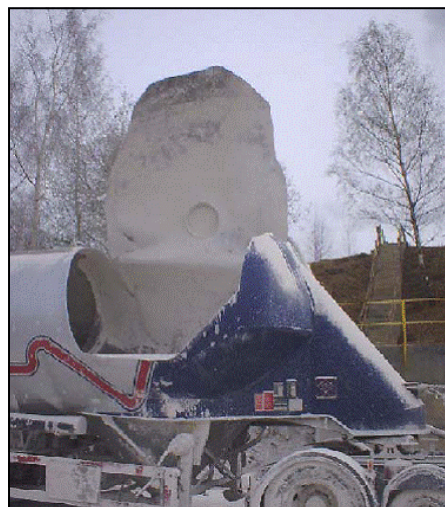
In an incident on a Tarmac site in 2005, pictured above, four people were

knocked to the ground and ten tonnes of cement were released. A further incident occurred at a CEMEX site in 2006 and two drivers were injured.

**In the meantime, drivers are reminded to check tankers for damage before discharging, as even what appears to be minor damage, can seriously affect the structural integrity of the tanker vessel.**

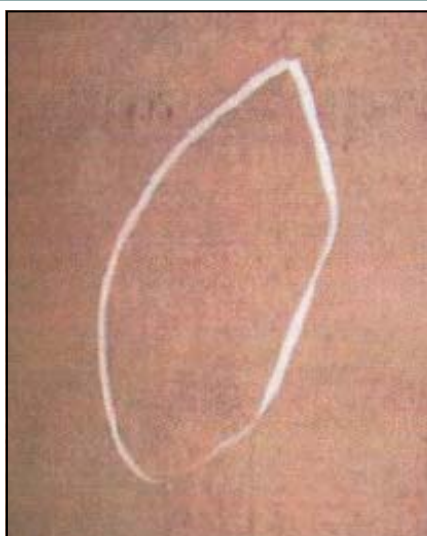
Plastic tie that caused a broken wrist

Strangely, the plastic tie incident was repeated on a concrete site when an employee fell and broke his wrist after his feet became entangled in the plastic tie pictured.

If sites were kept tidy and handrails were used properly, the majority of these incidents would have been avoided.

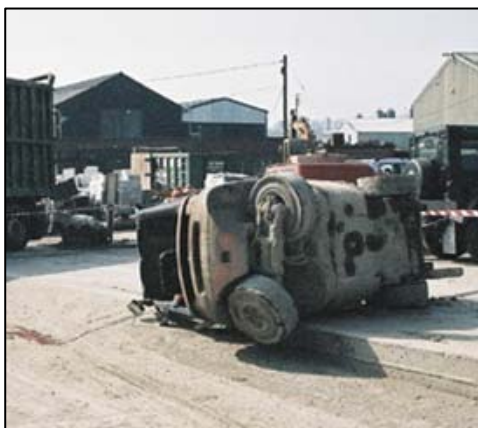
Fatal incident caused when forklift reversed over side of weighbridge. The drop was only a few inches high.

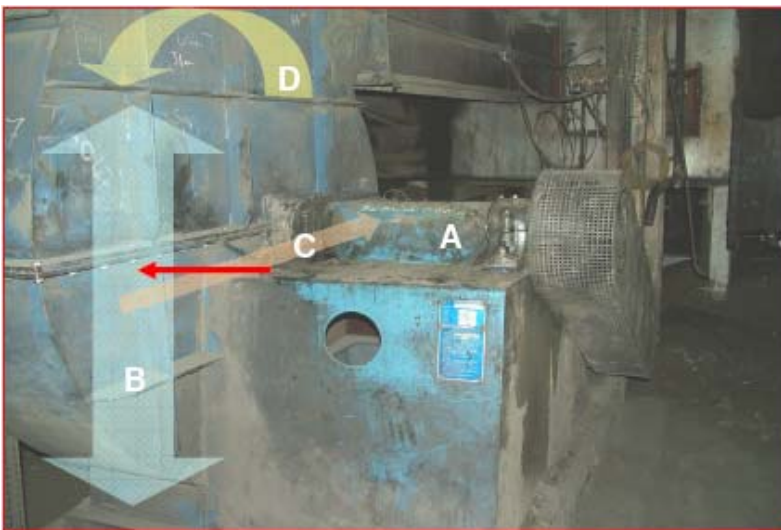
One of CEMEX's maintenance employees ended up in intensive care following an accident where he suffered a blow to his abdominal region whilst trying to immobilise a fan drive shaft. The fan had been electrically isolated but was turning in a reverse direction due to back-draft from the process. The injured man was working with a colleague to stop this movement so that a shaft bearing could be replaced.

It is believed that the injured person was attempting to fit a 900mm pipe wrench to the shaft, whilst his colleague was using a wooden wedge to slow down the rotation of the shaft through friction. It appears that the jaw of the wrench snagged the rotating shaft at an angle and as a result the wrench handle deflected into the employee's body.

The photograph shows the layout of the area. At the time of the incident the guard **A** was removed.

The injured man was standing in position **B** and it appears that the pipe wrench **C** was in the position indicated.

The fan was rotating in the direction **D** shown

The red arrow shows a possible direction of impact.

- **An improvised method was being used to stop the rotation of the shaft.**

- **A pipe wrench was used near rotating equipment.**

- **Use the right, well maintained, tools/equipment for the job. Never make do.**
- **Never work on live or moving machinery – always “lock out”.**
